Name Of Dam: LOWER NORTON RESERVOIR

Location: WISE COUNTY, VIRGINIA

Inventory Number: VA 19507

# PHASE I INSPECTION REPORT

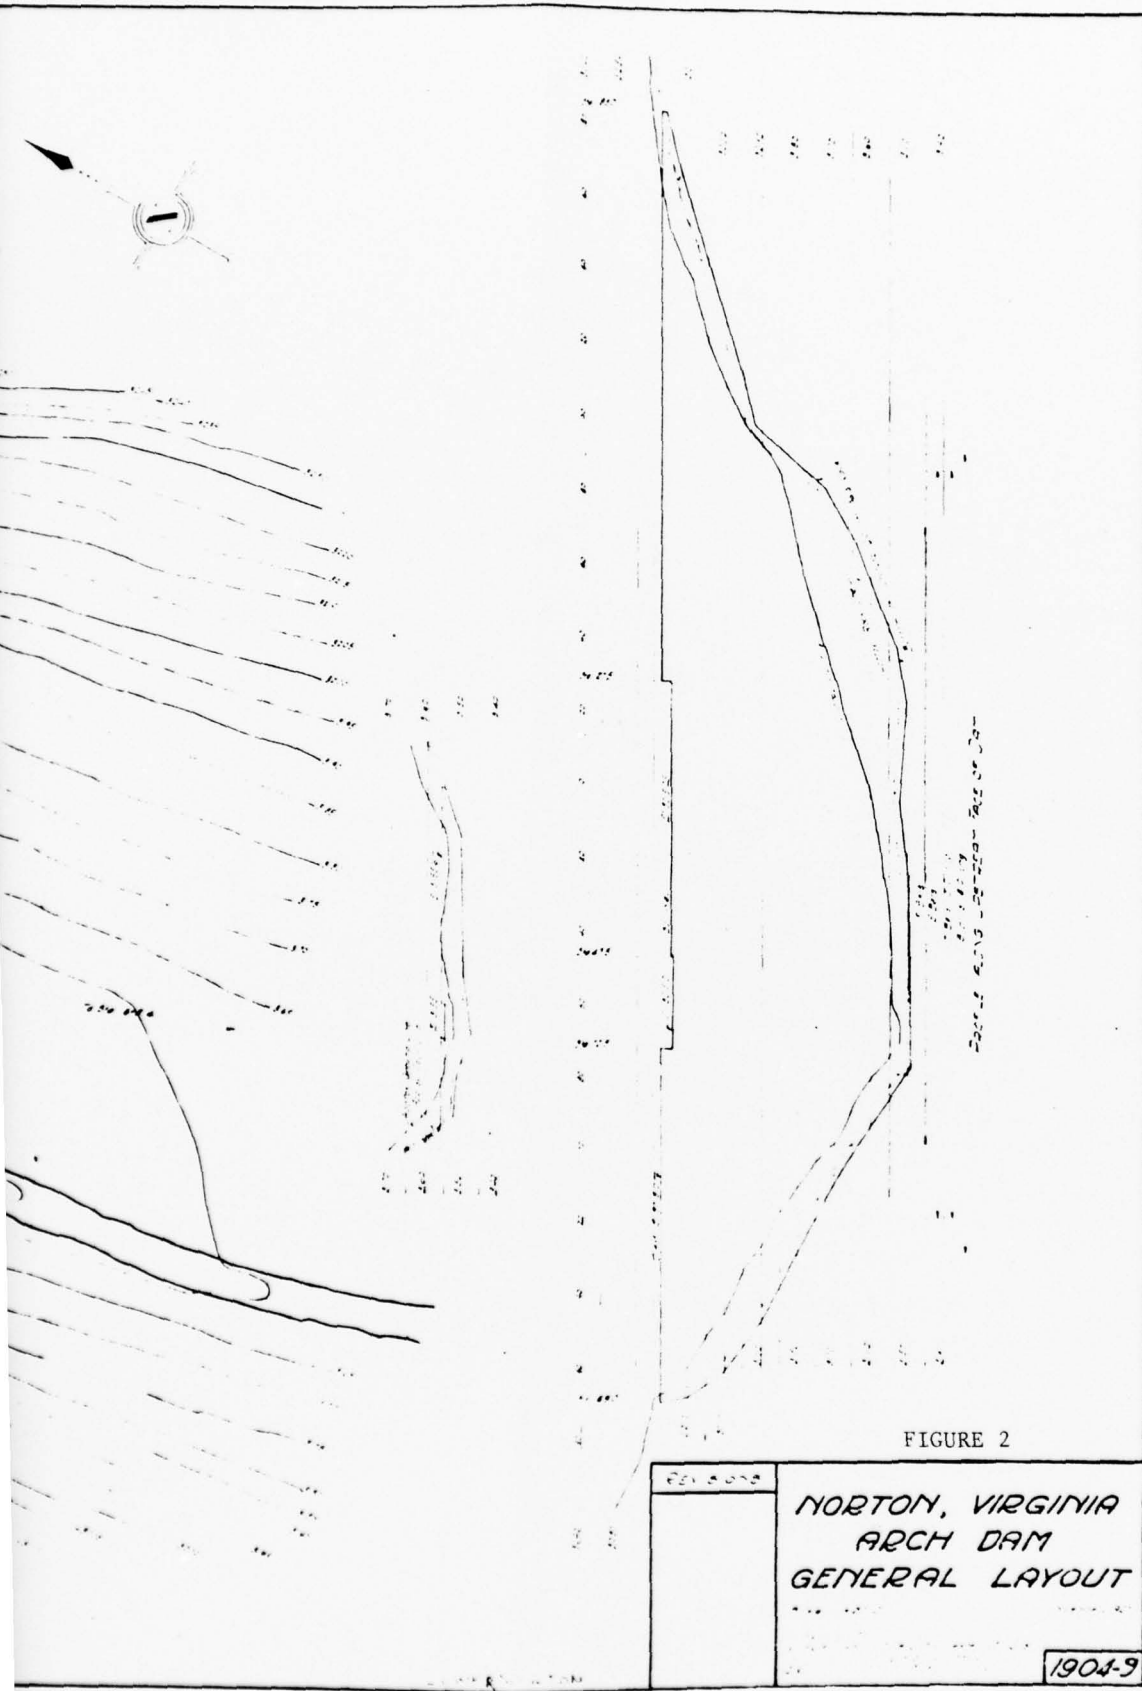
FIGURE 2

2.4        Evaluation: Much information on design, construction, and operation is not available. The boring logs given on the available drawing (Figure 2 of Appendix I) indicate that the borings were shallow and taken only 2 feet into the solid rock. The rock strata are also not adequately described. Among the missing items are:
